# Powder Cure Oven Upgrade

08/12/07

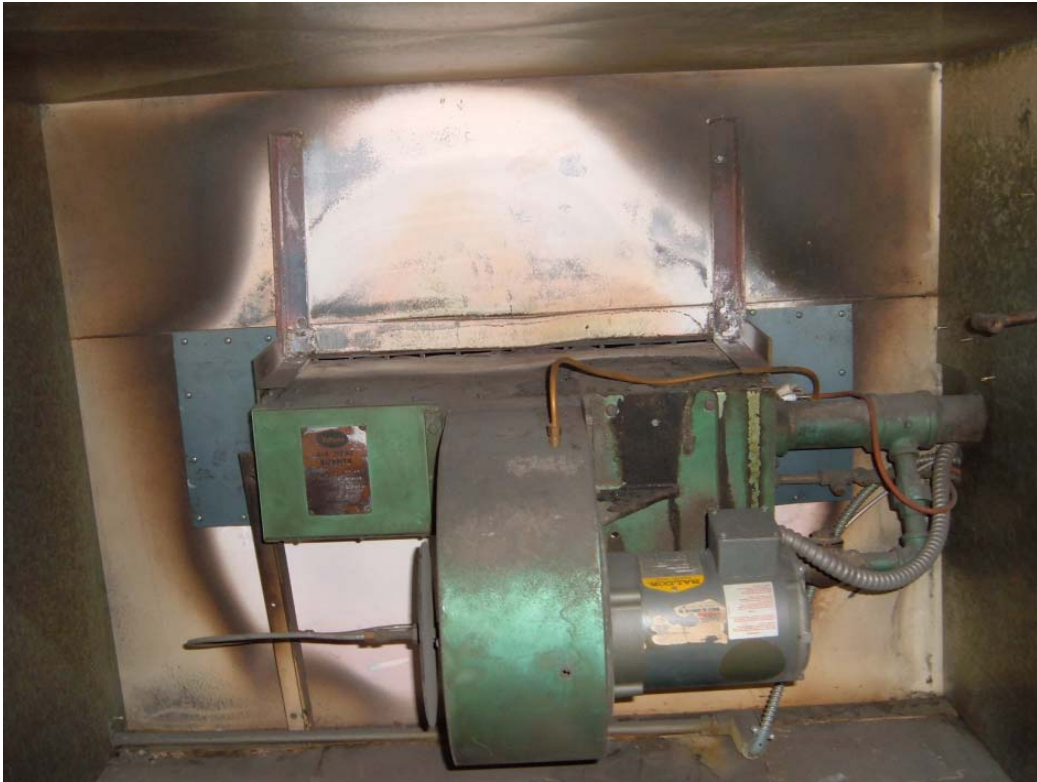
Bogh Industries LLC has completed a rework and upgrade of a powder cure oven located in Washington. The oven is an older panel oven installed in 1988. The oven had, over the years, experienced burnout in the burner box due to rich flame impinging the wall. Several repairs had been completed but a new repair was required due to the condition of the burner and burner box. The burner also showed significant damage due to burn back. (Wiring in a junction box was found to be melted together).

The picture shows the old burner with the heat damaged wall.

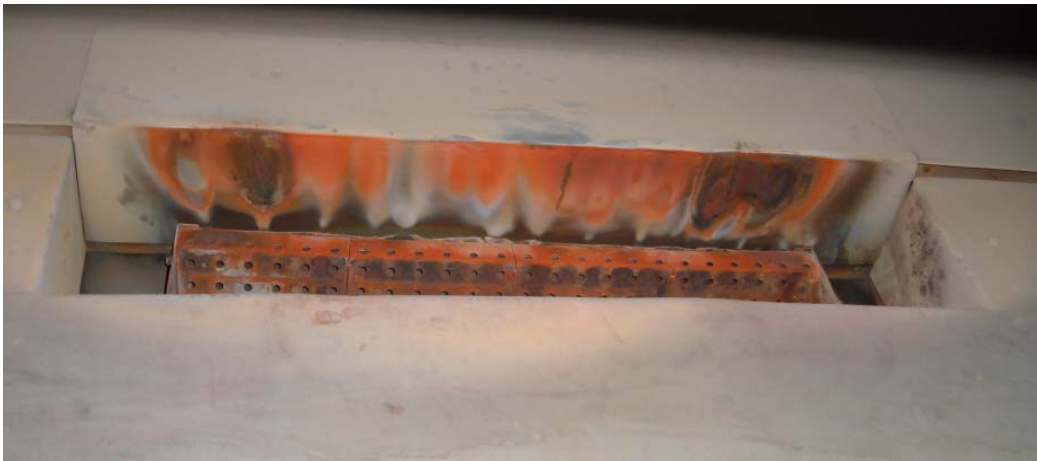
This picture show the inside of the burner box.

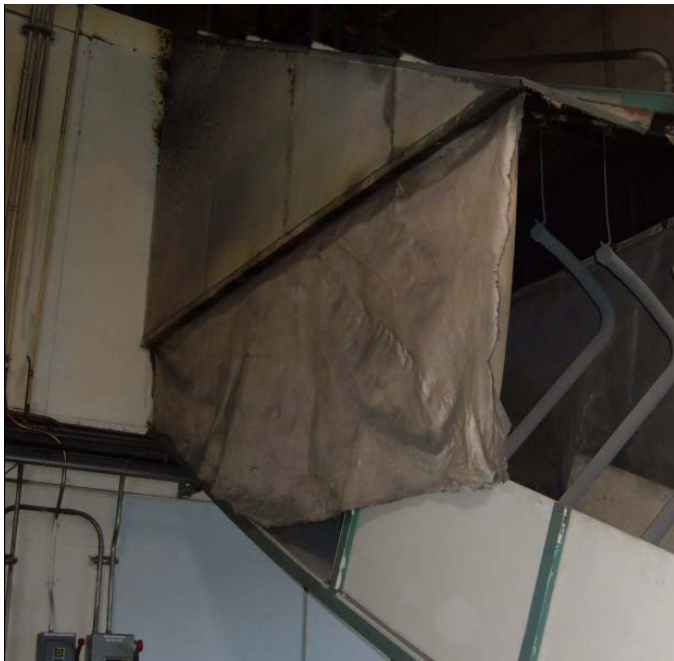
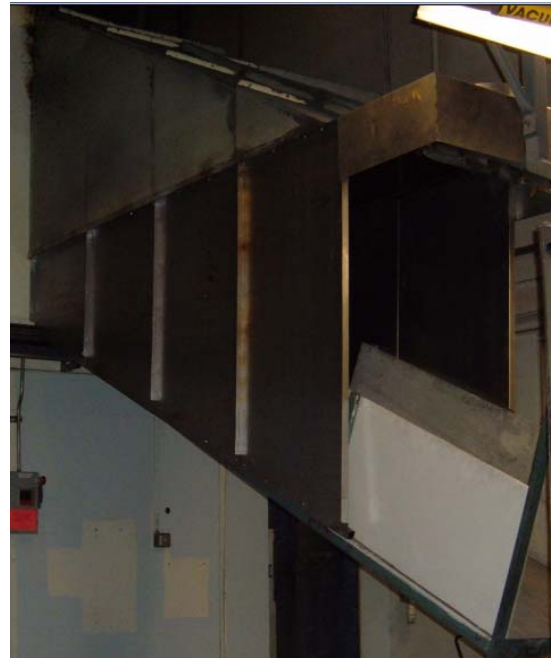
The vestibules on the machine were allowing air to enter the chamber and a significant heat balance problem existed both inside the oven and in the plant where the heat and fumes influenced the work environment in the plant.

The left picture shows the old vestibules with cloth sealing of the entry ways to the oven. On the right hand picture is the new sheet metal added including a hood which will be connected to the outside.

Bogh Industries installed as a turn key project. The plants maintenance personnel also provided help installing new burner and burner train plus two new vestibules and a modification to the last vestibule by replacing the cloth materials with sheet metal. Three new pieces of duct were installed inside the oven to eliminate a 120F uniformity problem. Balancing dampers were also installed to be able to better balance the oven's airflow.

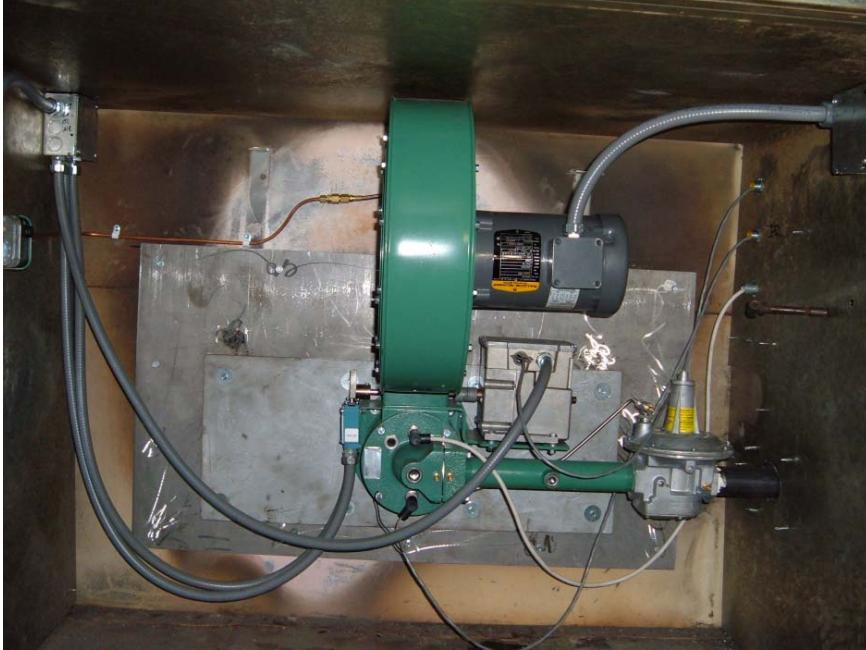
The new burner installed and repairs to the outside wall completed.

The new burner heated the oven up faster than the old and uniformity was improved to a state such that the line speed could be increased by 20-30%

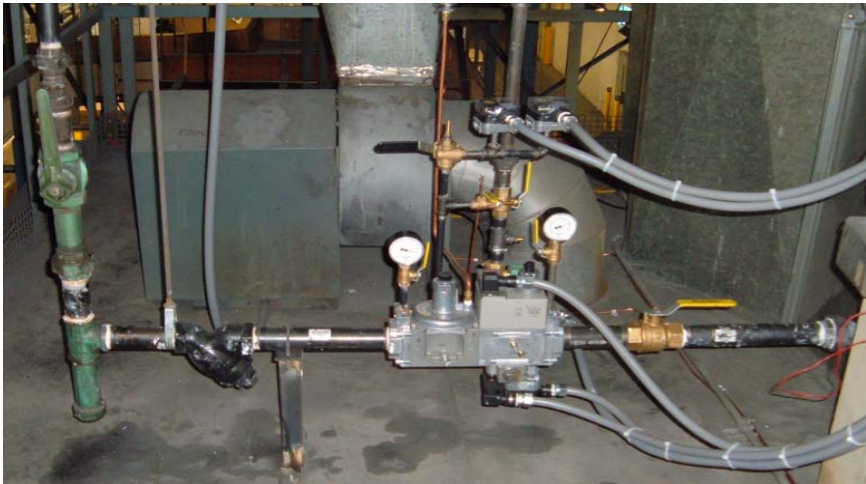
The new simplified modular gas train.

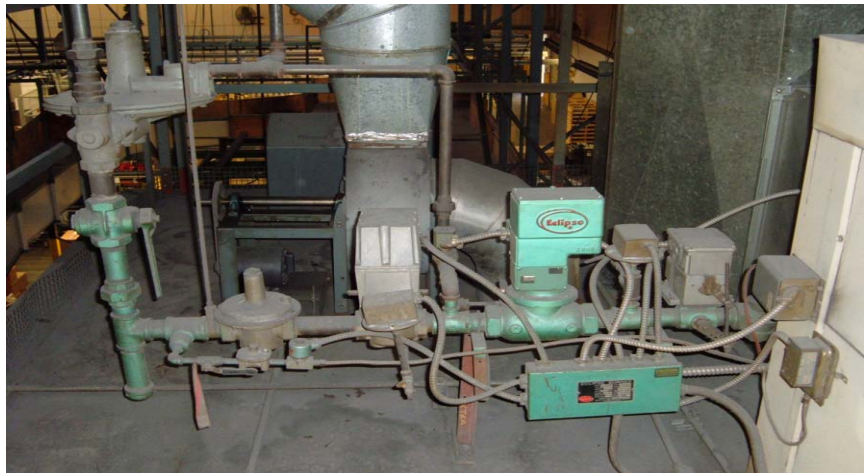
The picture shows the old gas train.

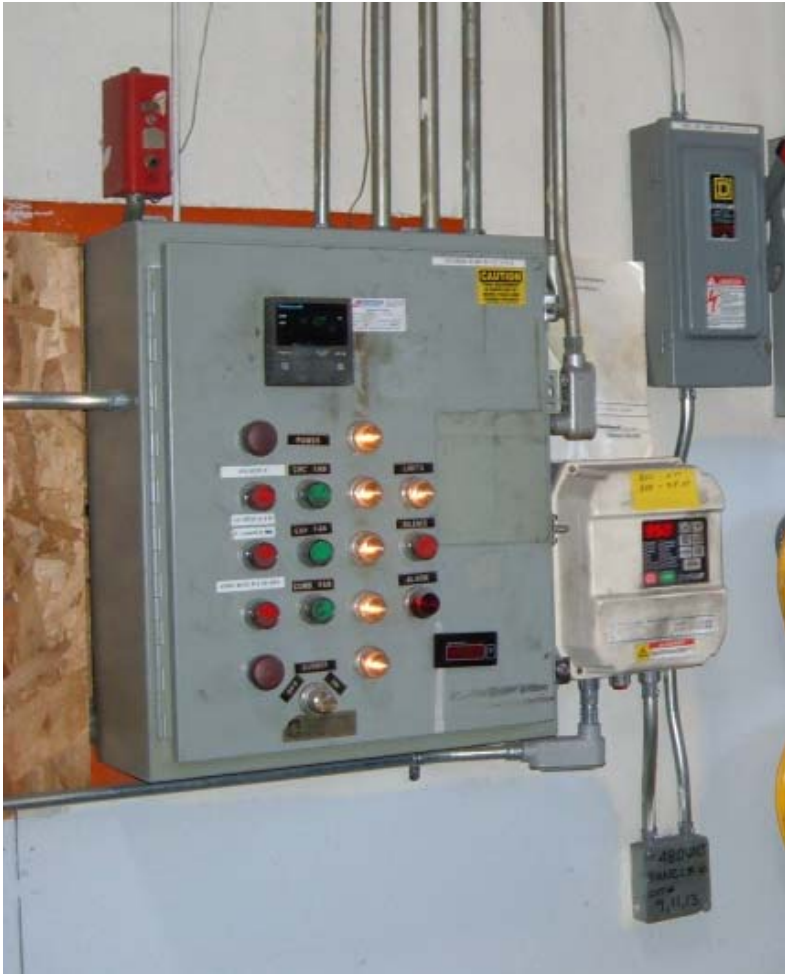
The old control cabinet.

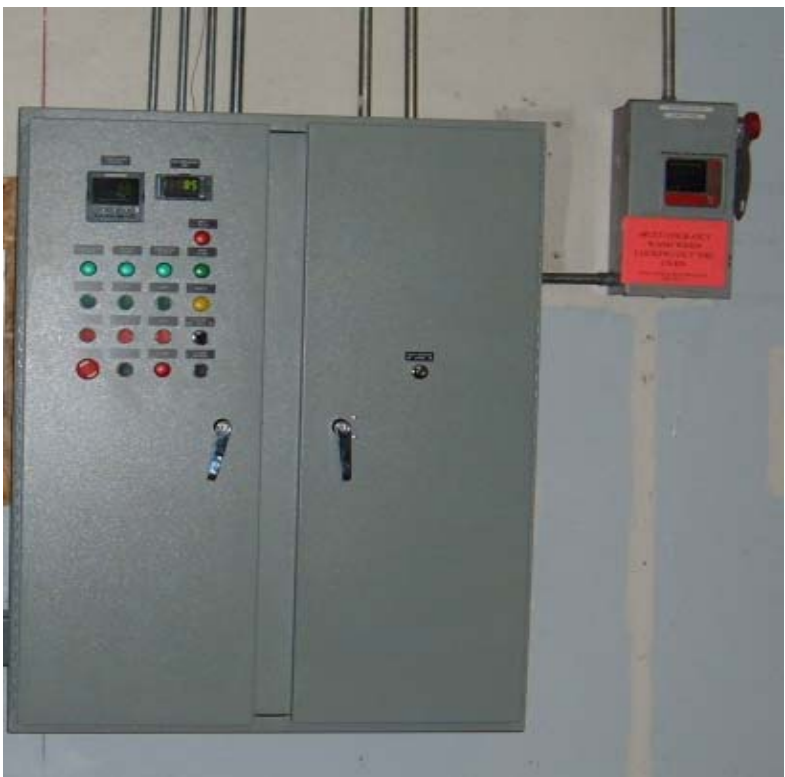
The new double door control cabinet.

In addition to the mechanical upgrades a full electrical upgrade was completed with new conduit control wiring and a control cabinet built with safety separation between the 480V and control power side of the cabinet. The pictures below shows the components installed. The whole repair and upgrade took 11 days from start to finish. This included the weekend.
