Fast track installation and commissioning. July 2006

Bogh Industries has recently been tasked with the installation and startup supervision of two pieces of equipment for a customer. The equipment was installed in Malaysia. The task was to install a drop bottom furnace with a 4x8x4 foot heat zone. The furnace is used for solution heat treat. The age oven has a 160”L x120”W x 110” H chamber. The time line for the installation required all major tasks to be completed in 30 days.

Quick Quench furnace

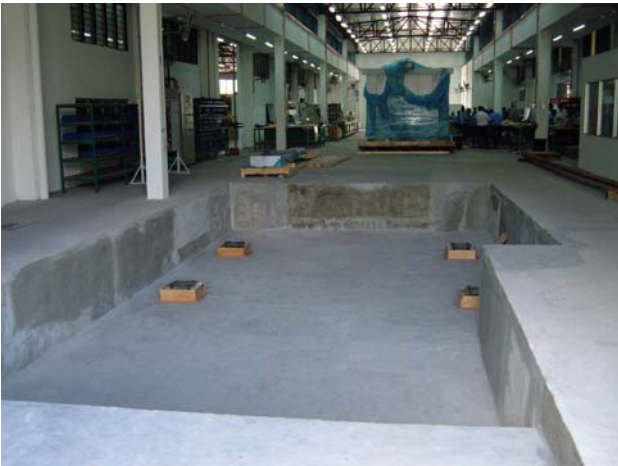
Figure 1: The start of the project. A concrete foundation consisting of a shallow pit is a part of the installation. The foundation was completed prior to the start of installation.

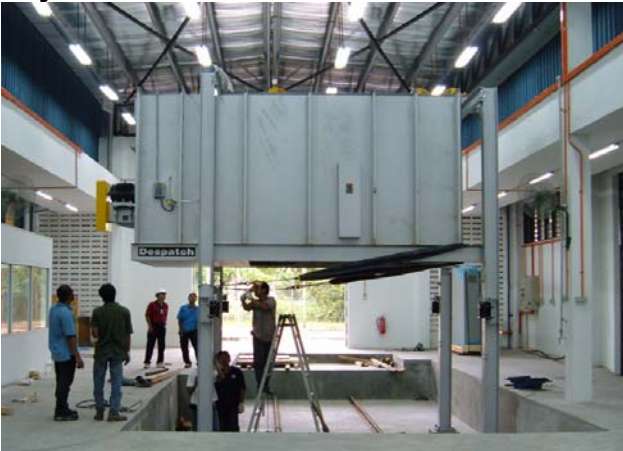
Day one

Figure 2: The furnace body is raised and secured between the four furnace columns.

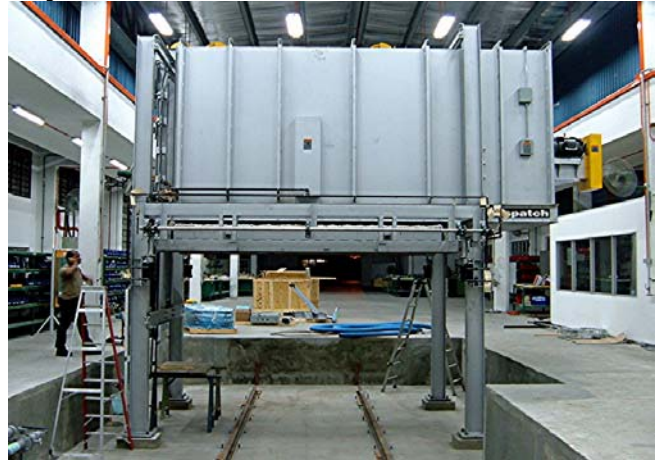
Day 2

Figure 3: Doors hoisted and air plumbing completed. The very tight space for using lifting equipment and the pit made any placement of the heavy pieces a challenge.

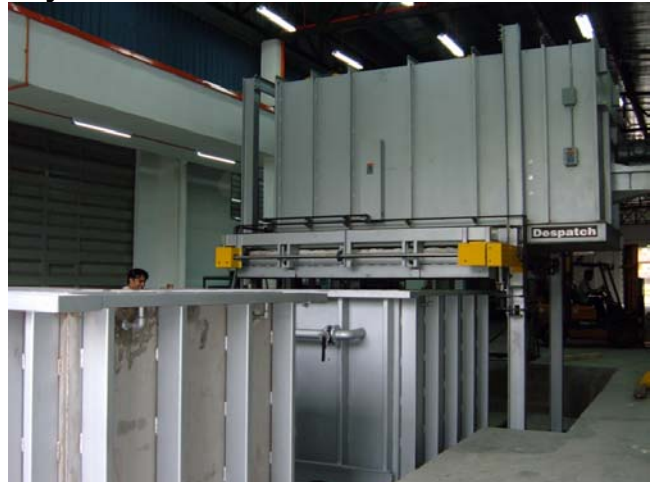
Day 3.

Figure 4: All major components installed and connected. (Furnace, Mobile Quench Tank and stationary rinse tank)

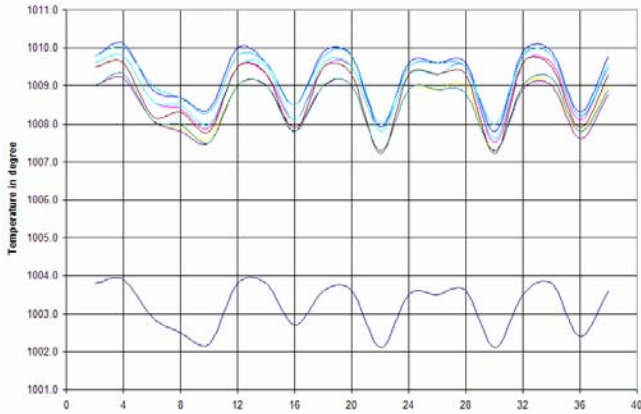
The furnace was factory tested by the manufacturer to the extent that heat had been applied and an initial survey completed. The data from the factory testing suggested that the furnace needed to have the PID loop tuned to a better parameter. This was completed in one day when the furnace was brought up to maximum operation temperature as part of the initial on site test.

Figure 5: The graph shows the oscillation on the PID loop and the spread on the TC's

With our experience it will be possible to achieve +/- 1C or better on this electric furnace with the proper adjustments and instrumentation.

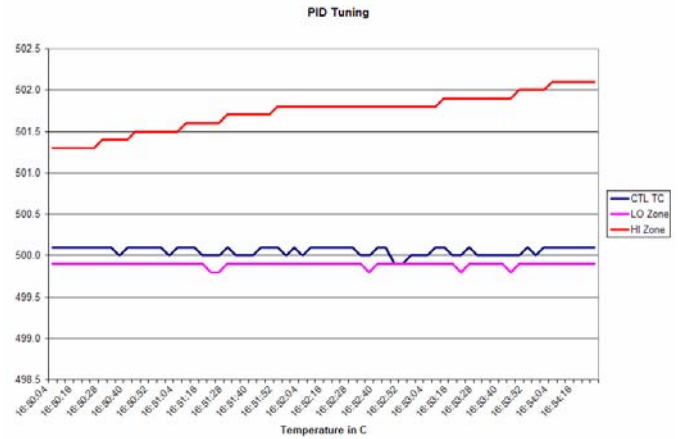
Figure 7: The figure shows how the control PID is holding temperature. (Blue line)

As shown on figure 6 and 7, the PID is now controlling very tightly and overshoot is practically eliminated. PID is now controlling the temperature within 0.2° C. Instrument calibration check performed later and the survey accomplished acceptable data for turning the furnace over to production. +/- 1.5°C. Better uniformity is possible but then additional survey time is needed.

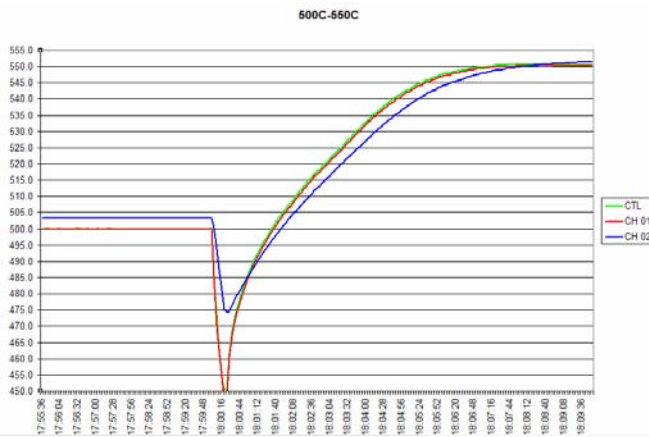
Figure 6: This graph shows the furnace recovery from 500C to 550C. It took 7 minutes for the furnace to reach temperature. The furnace has very fast recovery rates. First TC in soak was 7 minutes after the cold rack was inserted and the last TC was in soak after 13 minutes at the highest temperature (550C)

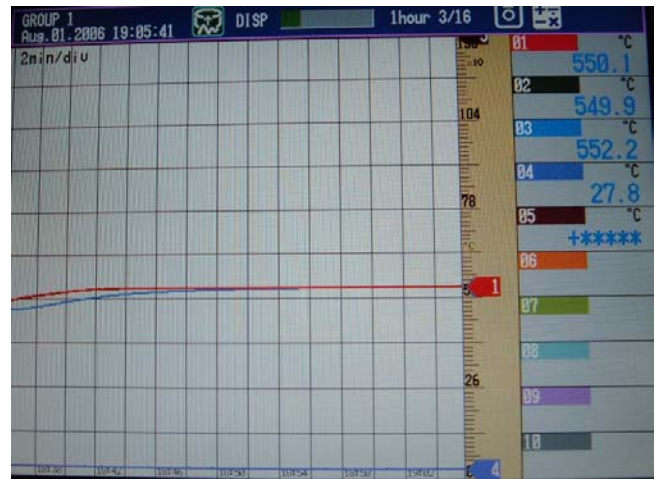
Figure 7: The picture show the machines recorder during the 550C test. No oscillation or overshoot.

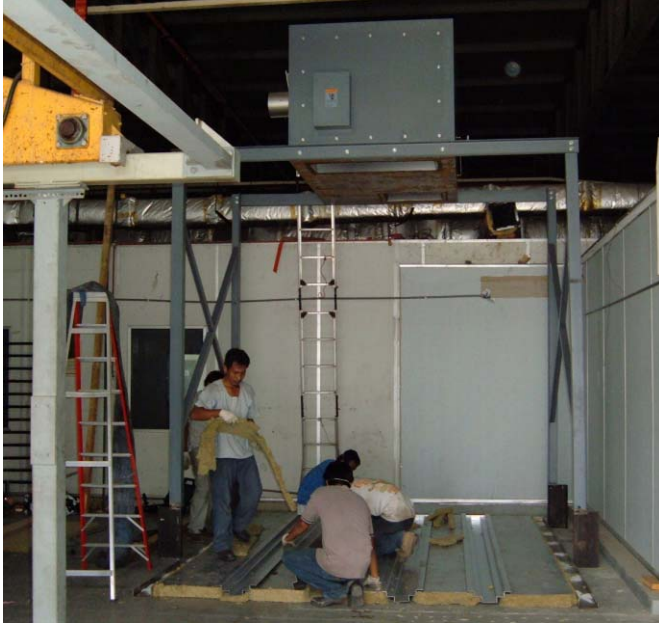
Day 1

Figure 9: Heater box was raised and the insulated floor assembled.

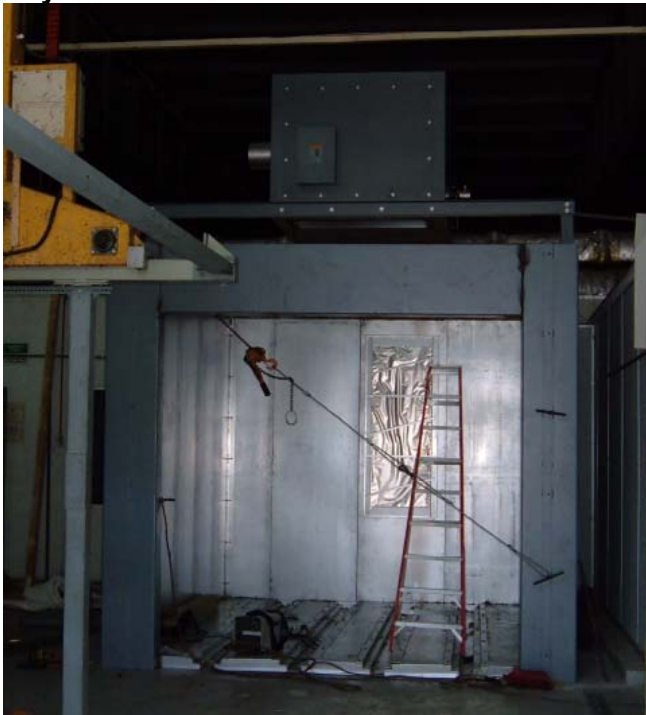
Day 2

Figure 10: The walls and roof is now shown assembled.

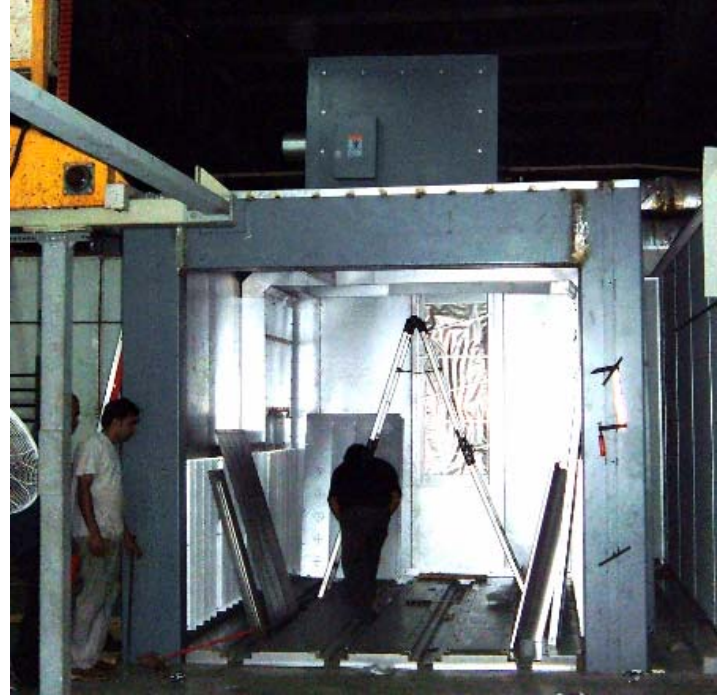
Day 3

Figure 11: The supply and return duct installed and the heater box placed in the proper position.

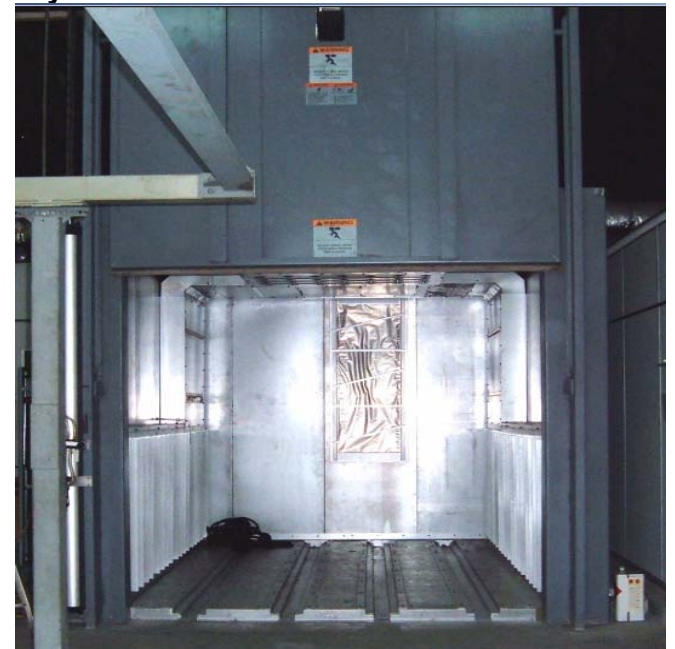
Day 4.

Figure 12. The door mast and door installed. The oven is mechanical complete.
